Doctor Inspector

Sample Report #1

Property address: 1234 Pretend Avenue

Inspection date: Thursday, June 11, 2009

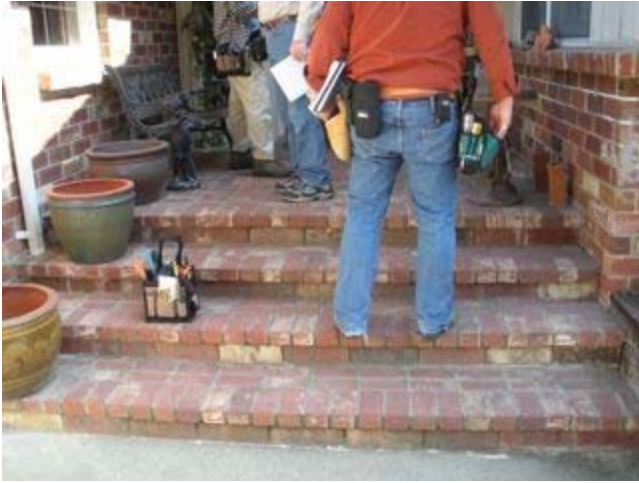
The front steps have four risers but no handrail installed. Due to the stairs' width, there should be a handrail on each side according to standard building practices. A qualified contractor should address this safety hazard by installing graspable handrails (that your hand can completely encircle) on each side of the front stairs.

Photo 5
No railings

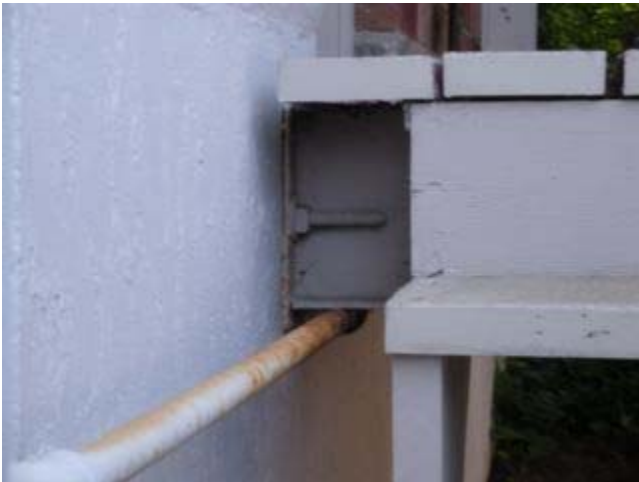
2) + The railing for the stairs on the west side of the house is somewhat rickety. Furthermore, it is supported by an insufficient number of balusters, allowing a person on the stairs to fall through. There is also a large enough gap between the stairs and the house, where there is no rail, that someone could fall off on that side too. These are all safety concerns. A qualified contractor should install additional balusters and shore up the railing on the side away from the house, and either install a rail and balusters on the house side or extend the treads to the siding.

Photo 6
Gap between stairs and wall

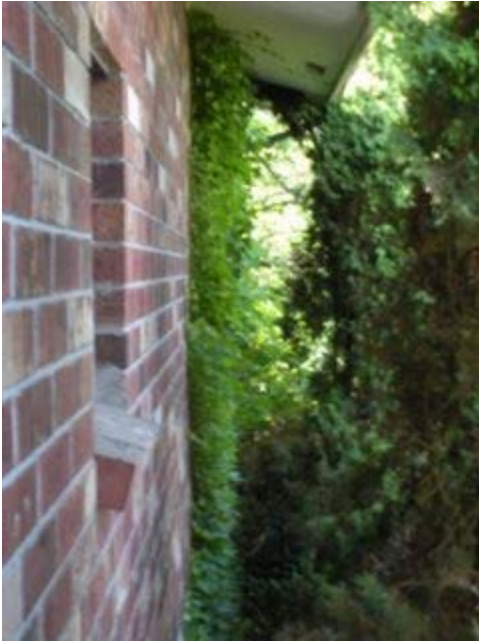
5) 🌳💧 Trees and shrubs are in contact with, or less than one foot from, the structure's exterior. Such vegetation can serve as a conduit for wood destroying insects and may retain moisture against the exterior after it rains. I recommend pruning vegetation or removing it altogether to maintain a one foot clearance between it and the structure's exterior.

Photo 7
Vines against house

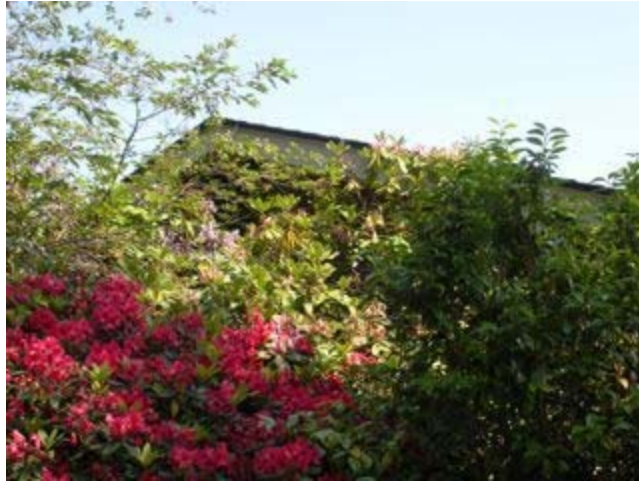
Photo 9
Close vegetation

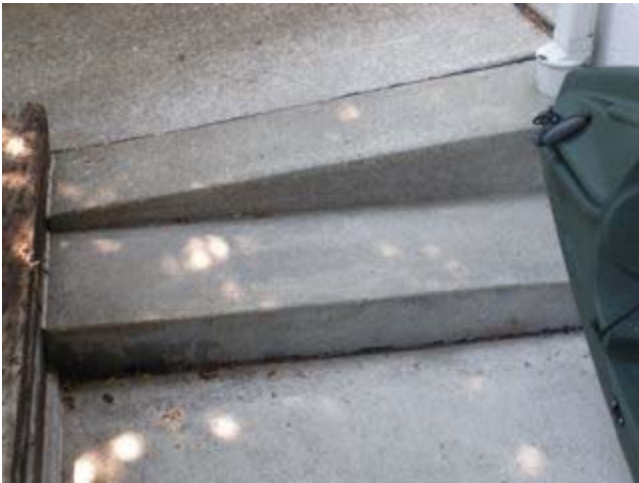
Photo 2

6) 🧑‍🔧 There are two minor trip hazards on the east side of the house. One is a height differential in the concrete where the ramped sidewalk begins to slope down at the front corner of the house. The other is the uneven riser of the top stair at the bottom corner. These aren't necessarily serious enough to warrant repairs, but heightened awareness is a good idea.

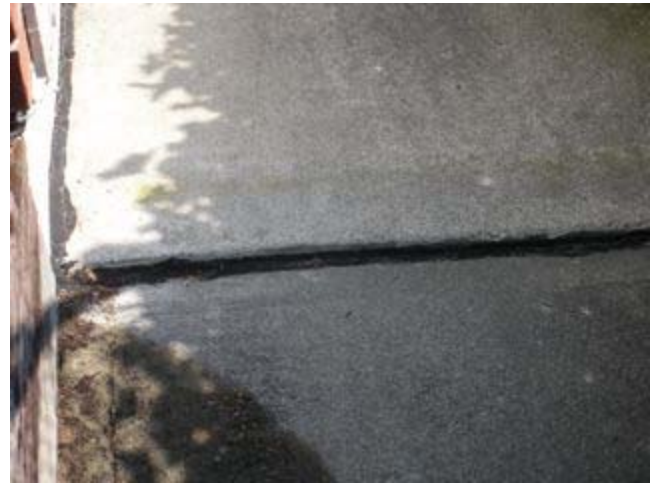
Photo 10
Trip hazard

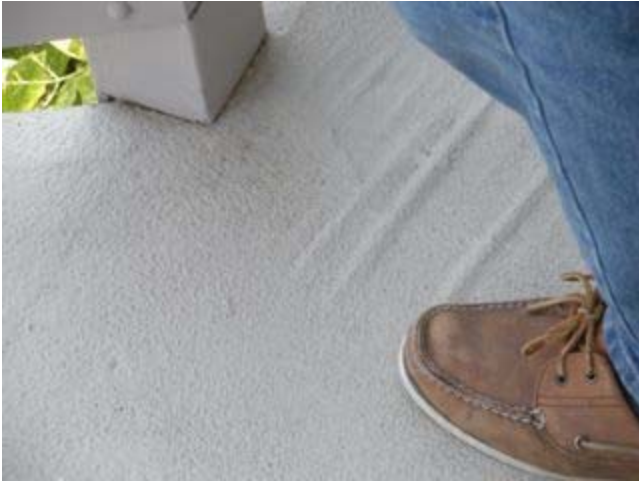
7) 🧑‍🔧 The rear (cantilevered) deck has an impermeable surface that is buckling slightly just to the right (east) of the sliding living room door. In the same vicinity, two nail heads are exposed and rusted. Also, the vinyl plate that covers the gap between living room windows and the sliding doors has warped. These three problems should be repaired by a qualified contractor.

Photo 12
Buckled deck covering

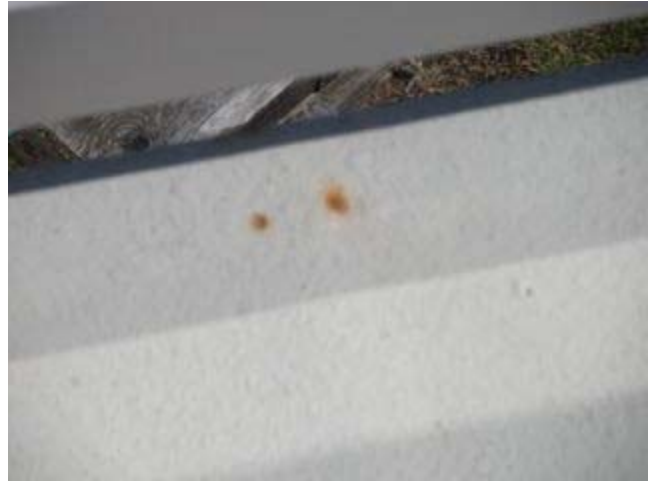
Photo 13
Rusted exposed nails on deck

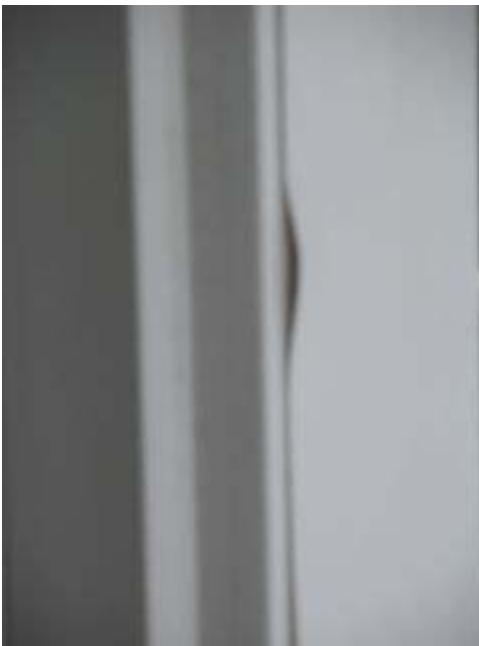
Photo 14
Warped vinyl covering

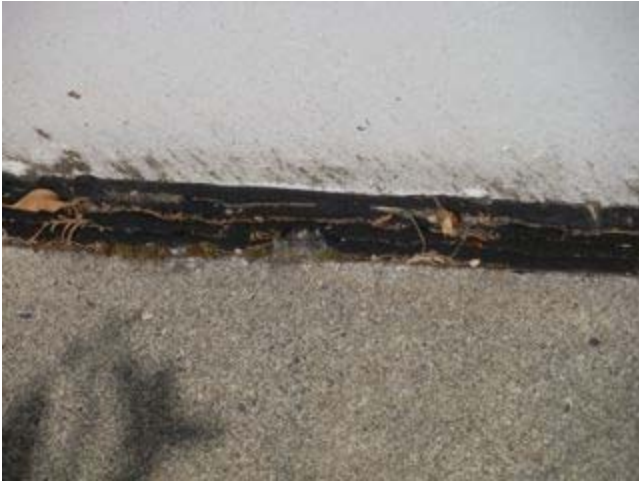
Photo 3

The seam between the sloped walk and the house on the east side is sealed with tar or a tar-like substance. This kind of sealant cracks and requires periodic maintenance to keep water from working its way into the structure.

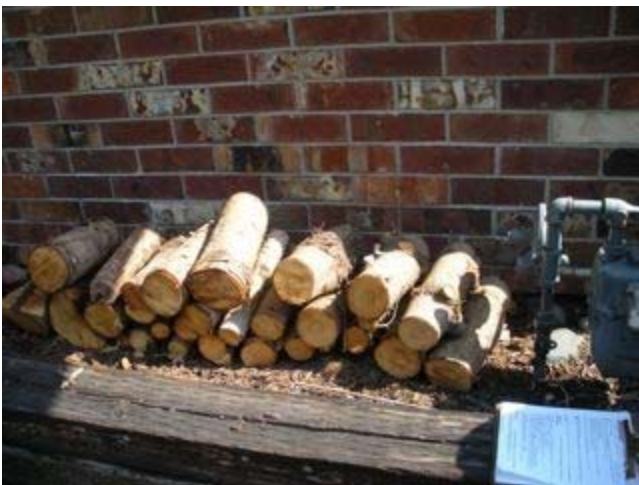
Photo 4

9) 🗝️ 💧 Firewood is stored so that it's either in contact with the structure or very close to it. In addition, the planter upon which it rests brings dirt within 6 inches of wood siding. These are conducive conditions for wood destroying organisms. I recommend storing firewood as far away from the house as practical (standard practices recommend at least 25 feet) and either lining the planter box or widening the clearance between soil and wood.

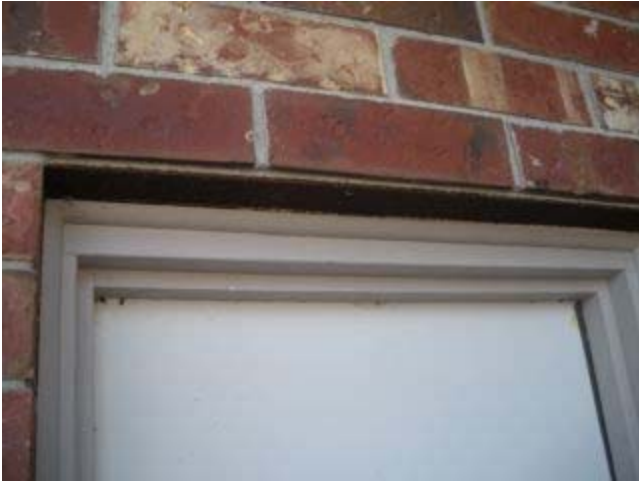
10) 🏠 The masonry lintel above the top door on the west side of the house is rusted. This can lead to expansion and horizontal cracking in the mortar. No damage was evident at the time of inspection. I recommend careful monitoring.

Photo 8
Rusted lintel plate

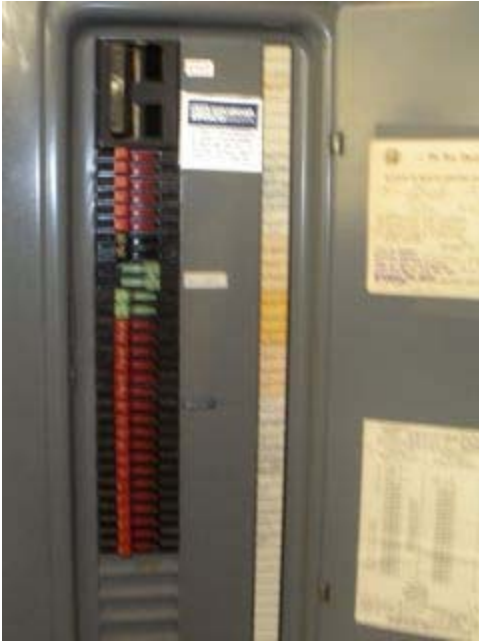
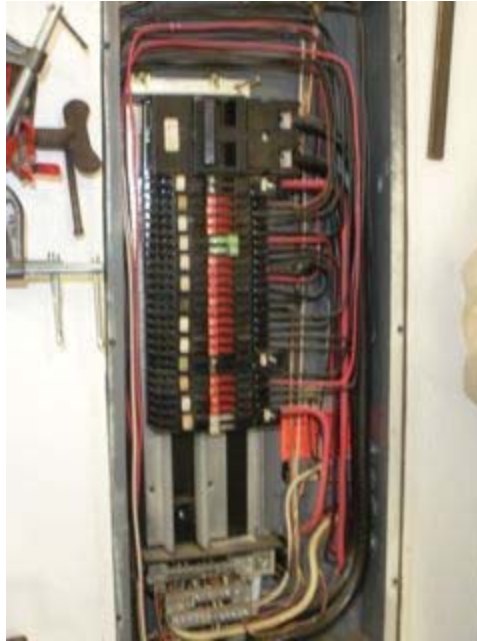
This property has two Zinsco brand main service panels. These panels and their circuit breakers have a variety of problems including:

- Bus bars made from aluminum that tend to oxidize and corrode
- Breakers that don't trip under normal overload conditions
- Breakers that appear to be tripped when they're not

These problems are a safety hazard due to the risk of fire. At the time of inspection the panels were clean and there was no evidence of malfunction. Nonetheless, I recommend having a qualified electrician thoroughly evaluate the panels and components within and make repairs as necessary.

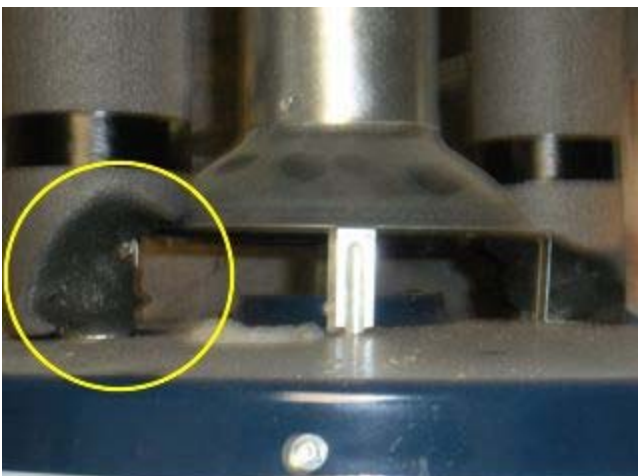
Photo 21

19) ✋ Foam insulation on water supply pipe(s) at the top of the water heater has melted due to the heat from the draft hood. This is a safety hazard since this insulation is flammable. The insulation should be trimmed so it is at least a few inches from the draft hood.

Melted insulation

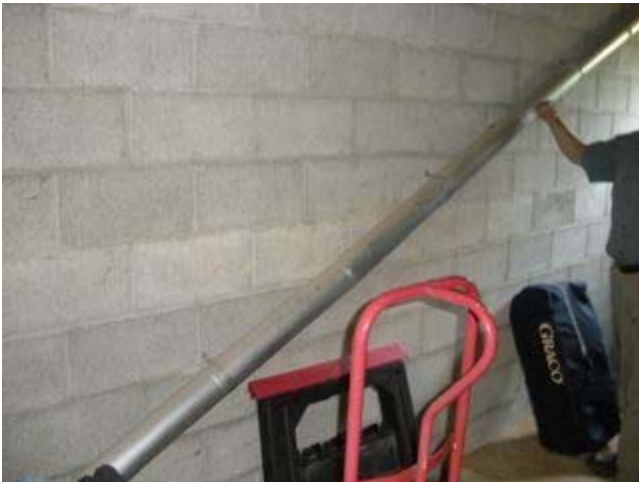
The clothes dryer exhaust duct is too long and vents upward at too great an angle. It also is not insulated in an unconditioned space (i.e., basement). These conditions may reduce the air flow through the duct and also cause condensation in the duct, resulting in overheating, reduced efficiency, duct deterioration, and difficulty in cleaning the duct. A qualified contractor should modify the exhaust duct as per standard building practices.

Photo 20
Dryer vent

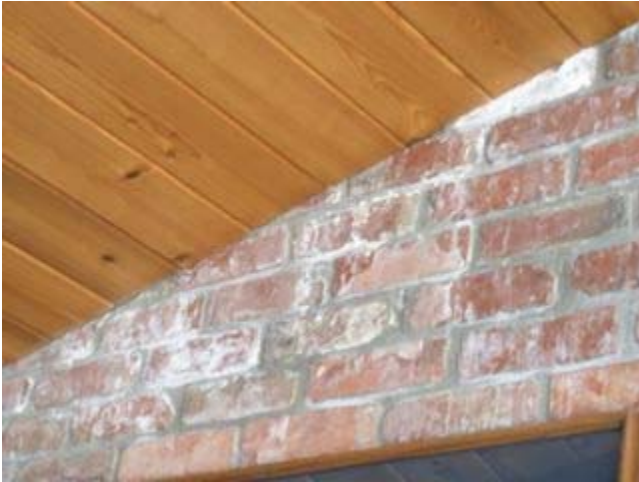
The chimney masonry in both the living room and kitchen shows efflorescence. This is

caused by moisture seeping through the brick and depositing salts upon evaporation. Owner informed inspector that this was caused by a leak in the flue that has since been repaired.

Photo 17
LR efflorescence

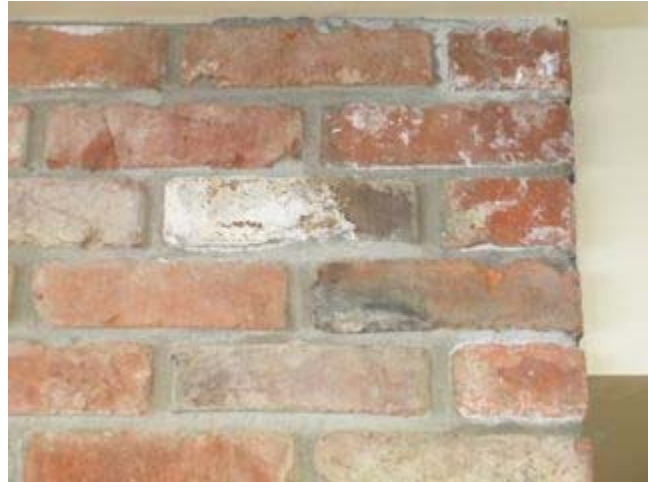
Photo 18
Kitchen efflorescence

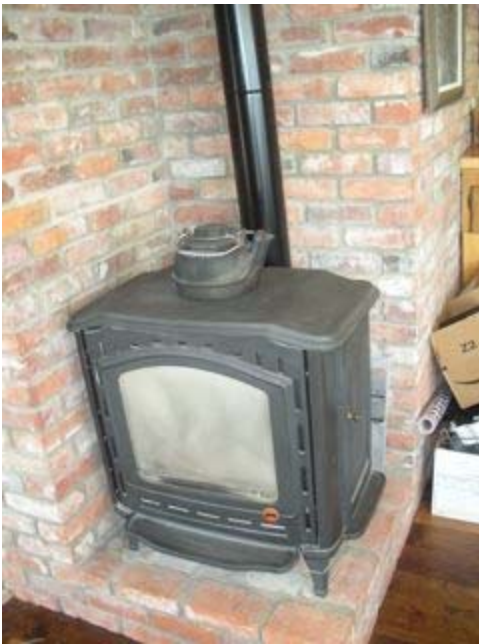
Photo 16

The pilot light for the dining room gas stove was turned off. The fireplace insert was also turned off. As per the Standards of Practice for both the [National Association of Certified Home Inspectors \(NACHI\)](#) and the [American Society of Home Inspectors \(ASHI\)](#) the inspector does not operate gas shut off valves or light pilot lights during inspections. These appliances were not fully evaluated, but it was noted that the dining room stove needs servicing.

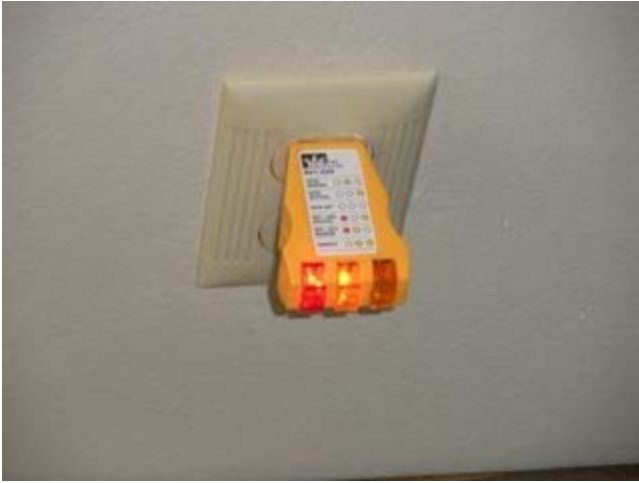
Photo 19

The downstairs west-side bedroom has a receptacle with reverse-polarity wiring (hot and neutral wires reversed). It is highly likely that the receptacle is on the same circuit as the one on the other side of the wall (outside) with the same condition (see Exterior section). This is a safety concern due to risk of shock. A qualified electrician should make needed repairs.

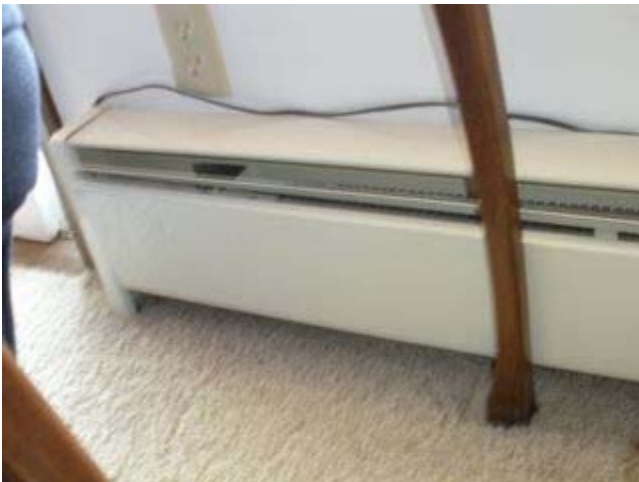
Photo 11

33) 🔍 Throughout the house there are electric receptacles directly above the baseboard heaters. This is a safety concern in that wires plugged into the receptacles tend to drape over the heater and overheat. Caution is warranted. In addition, there is a low-voltage wire draped on top of the living room baseboard heater. This should be evaluated by a qualified electrician to assess its safety. (Low-voltage wiring and components are excluded from this report.)

Curious wire
