Doctor Inspector

Sample Report #2

Property address: **30 Something Street
Bellingham, WA**

Inspection date: **6-12-2009**

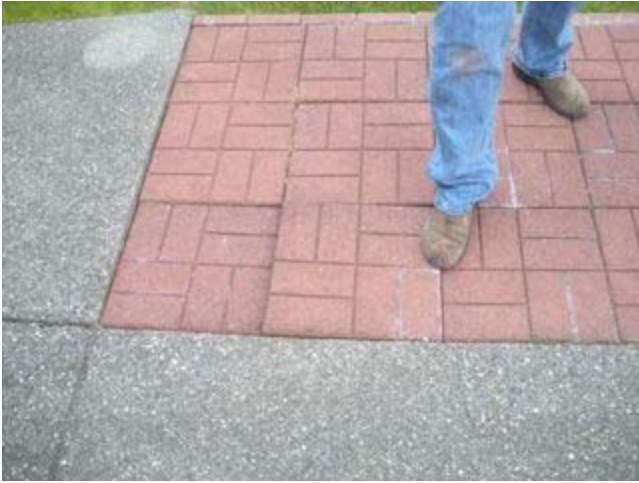
Photo 4

Some of the pavers along the driveway are loose and pose a trip hazard. A qualified repair person should firm these up.

Loose sidewalk pavers

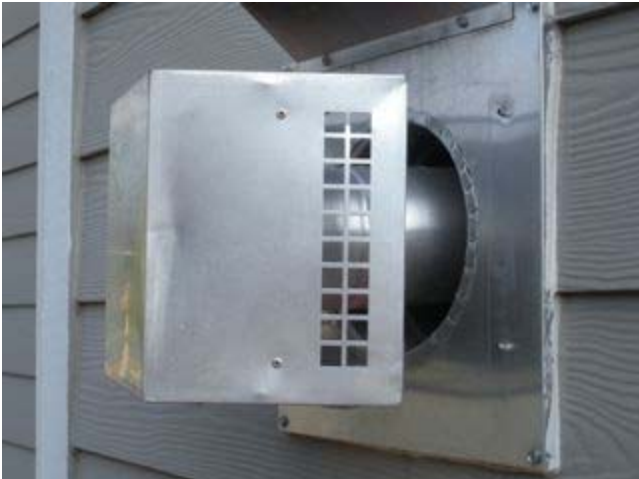
Photo 2

5) 🛠️ The fireplace exhaust vent is damaged or broken; it juts out too far. I recommend a qualified HVAC repair person repair or replace as needed.

Faulty fireplace vent

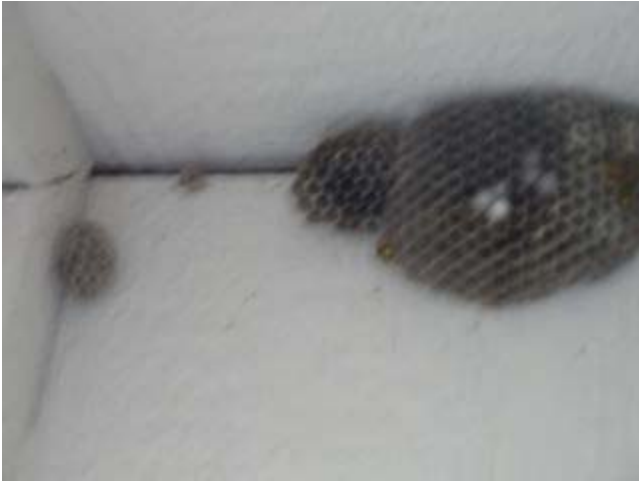
8) 🛠️ Several wasp nests were found in the eaves. These can pose a safety hazard and should be removed as necessary.

Photo 6
Wasp nests in eaves

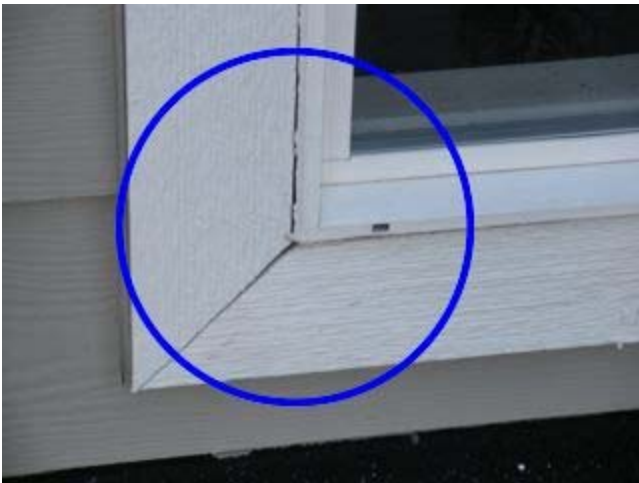
- 9) 🗝️ 💧 Some window frame joints exhibit wide enough gaps that they should be caulked.

Photo 7
Needs caulking

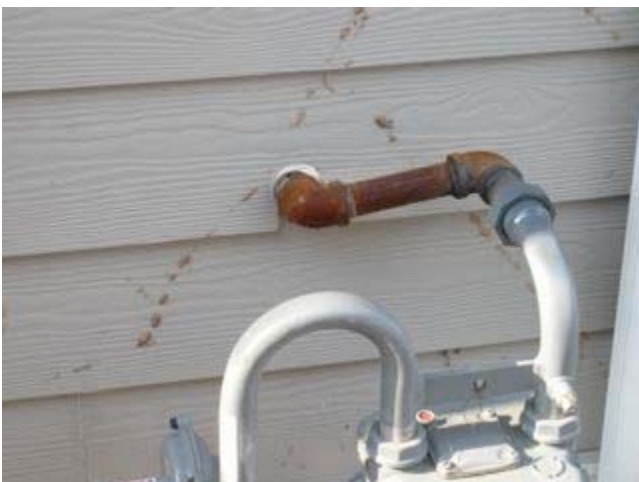
Photo 3

- 10) ⓘ There is cosmetic damage to the siding on the north wall near the northwest corner. This may be from vines growing against the house which have since been removed.

Vine evidence

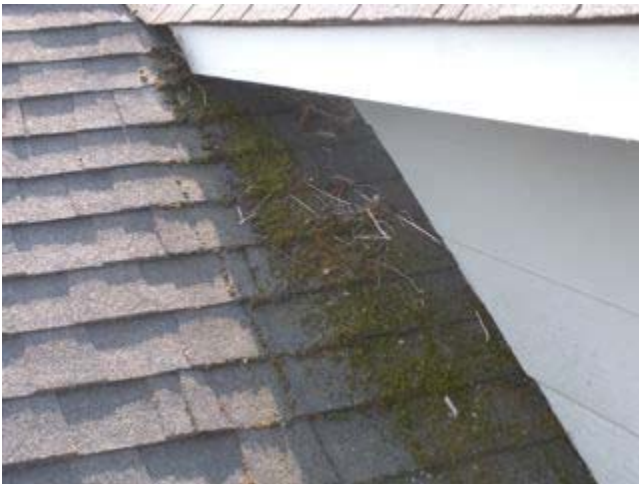
Photo 5

Moss is growing on the roof, particularly on the north side of the dormer. This could lead to damaged shingles and leaks, and it's a conducive condition for wood destroying organisms. I recommend applying zinc-based chemicals periodically to keep the moss under control. For information on various moss treatment products and their pros and cons, visit:

Moss on roof

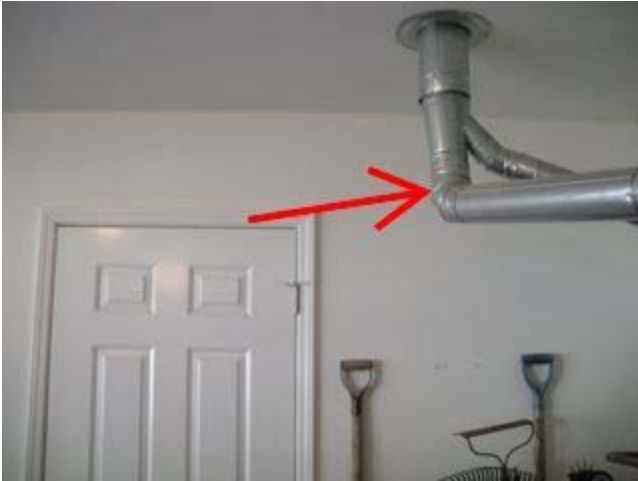
The exterior door on the north wall has a hinge-based doorstop that can be unreliable. If this door were to swing far enough into the garage, it would crash into the vent flues for the water heater and furnace. This could lead to carbon monoxide spilling into the garage. I recommend having a qualified contractor install a positive doorstop on the stoop.

Photo 9
Better doorstop

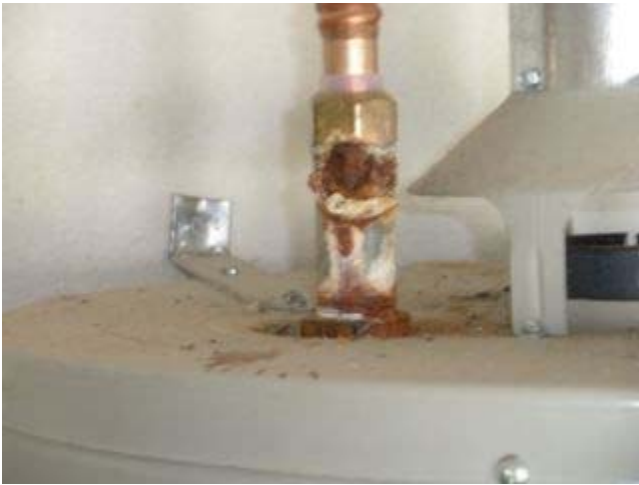
Photo 8

13) 🛠️🔍 The supply line to the water heater is corroded, possibly from a leak. (No water was present at the time of the inspection.) A qualified plumber should evaluate and replace or repair the

pipng if necessary.

Water heater corrosion

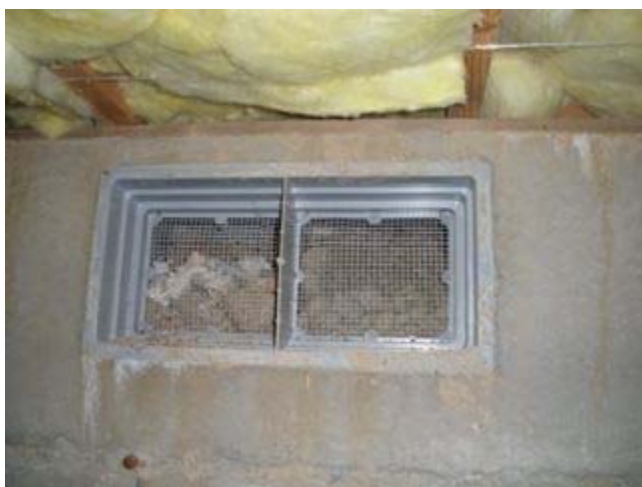
19) 🧰💧 All crawl space vents are blocked by removable Styrofoam panels. In addition, one is blocked by soil and rock (it is completely below grade without a well). Venting blockage typically promotes high levels of moisture in the crawl space, which in turn is a conducive condition for wood destroying organisms. I recommend all vents be opened.

Photo 12
Rocks blocking vent

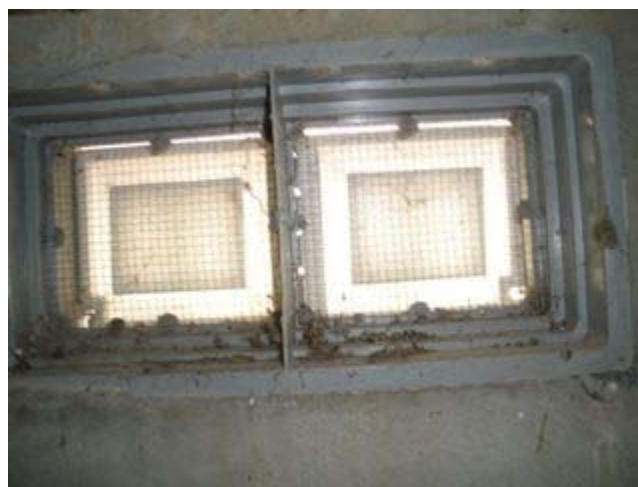
Photo 13
Blocked vent from crawl space

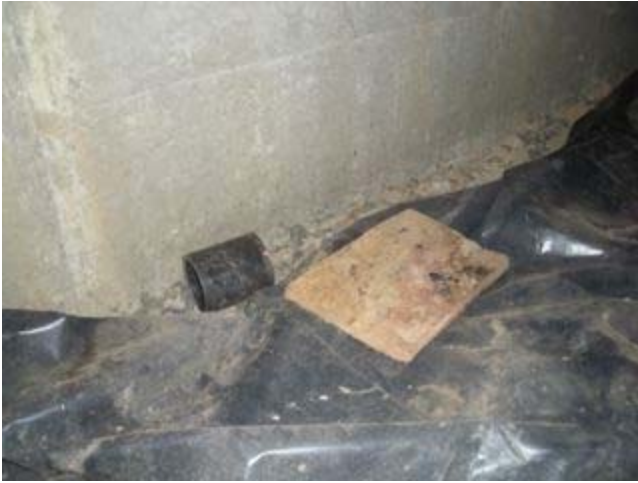
20) 🧰💧 Cellulose-based debris was found in the crawl space. It should all be removed to avoid attracting wood destroying insects.

Photo 14
Cellulose debris

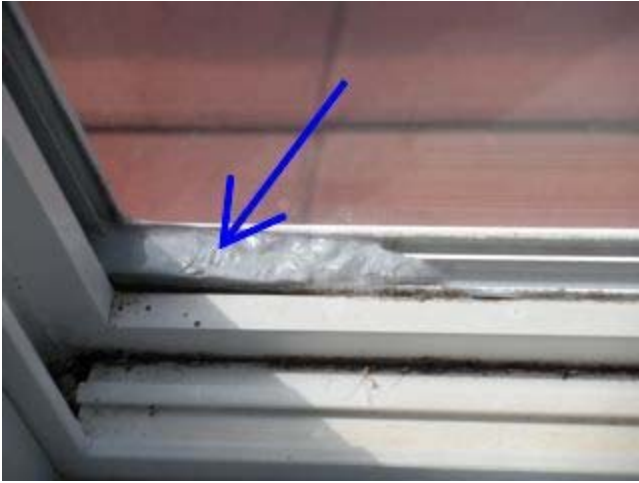
- 25)** 🔧🔍 The sealant in the south wall thermal-pane windows has melted, reducing or eliminating the window's effectiveness. I recommend evaluation of all windows by a qualified window contractor to determine whether the failed windows are under warranty and to replace windows as necessary.

Photo 11
Melted thermal sealant

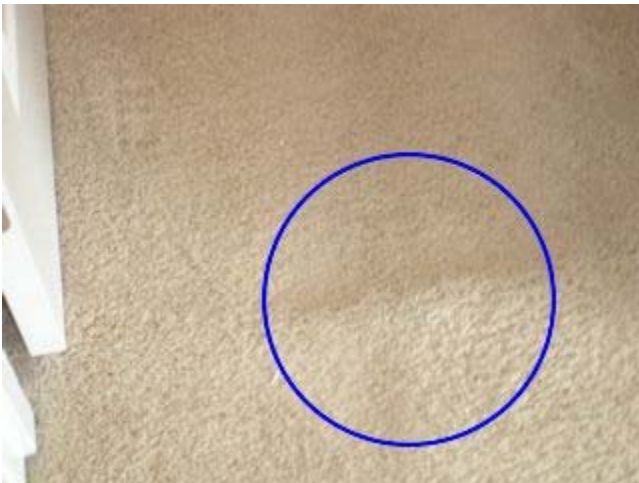
26) 🙌 The carpeting has buckled somewhat in several rooms. I recommend having a qualified carpeting contractor make needed repairs.

Photo 10
Buckled carpet
