Doctor Inspector

Sample Report #1

Property address: 1234 Pretend Avenue

Inspection date: Thursday, June 11, 2009

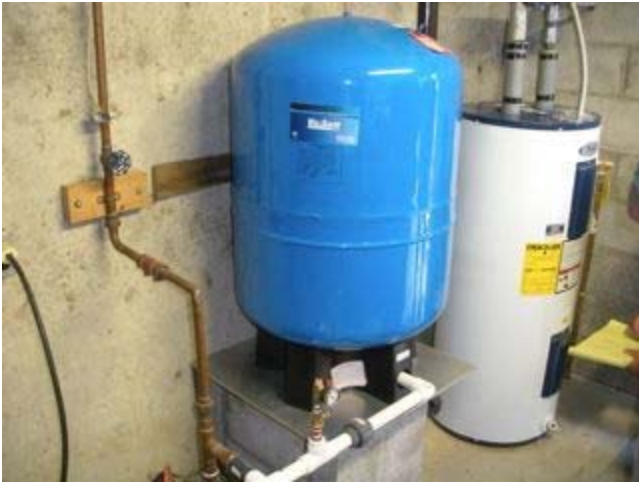
Photo 22

26) The second water heater (electric) is located in the unfinished basement, as is the "Well Saver" expansion tank for supplying water to the house from the lake.
